## ASBESTOS SCREENING REPORT

Rosedale Tower  
2314 W 39th Ave  
Kansas City, Kansas 66103

Hernly Environmental, Inc.  
Michelle Nelson & Katie Burnham  
AHERA Asbestos Inspector Cert. #  
7ACT031022IR-4793 & 7ACT031022IR-4792  
1100 Rhode Island Street  
Lawrence, Kansas 66044  
TEL: (785) 749-5806  
www.hernly.com  
HA Project No.: 220811-01MK

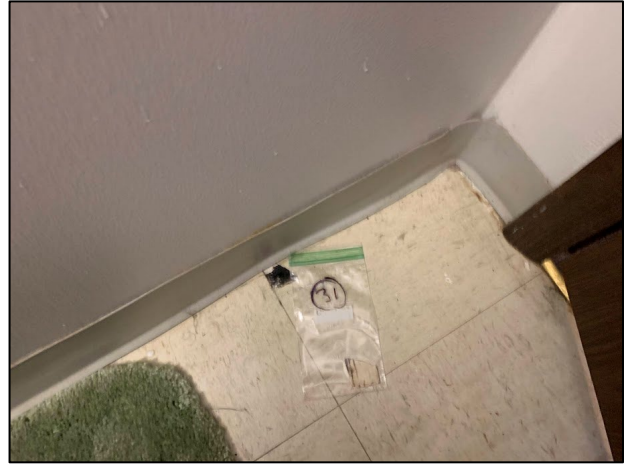
**Sample #31 cream 12x12 floor tiles & mastic**

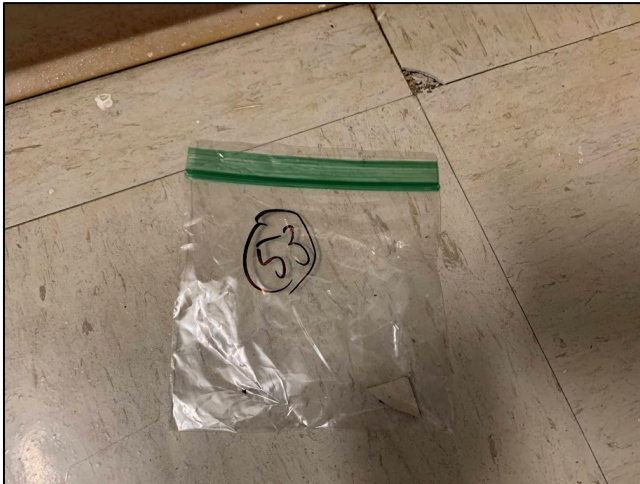
<b>484611-052</b>	08/11/22	52	906 KT Under Sink		
Layer 1:	Sink Insulation Black, Brittle			No Asbestos Detected	100% NON FIBROUS MATERIAL
<b>484611-053</b>	08/11/22	53	905 BA FL		
Layer 1:	Floor Tile Cream, Organically Bound			2% CHRYSOTILE	98% NON FIBROUS MATERIAL
Layer 2:	Mastic Black, Bituminous			2% CHRYSOTILE	98% NON FIBROUS MATERIAL

**Sample #53 cream 12x12 floor tiles & mastic**

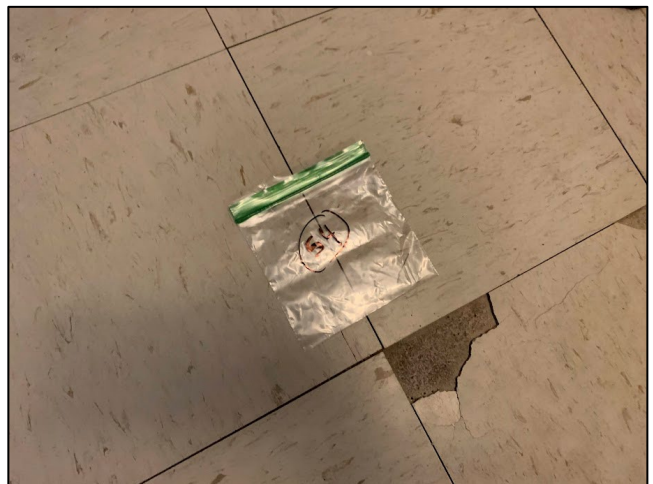
Sample ID	Collected	Cust. ID	Location	Asbestos Fibers	Other Materials
<b>484611-054</b>	08/11/22	54	809 BA FL		
Layer 1:	Floor Tile			2% CHRYSOTILE	98% NON FIBROUS MATERIAL
	Cream, Organically Bound				
Layer 2:	Mastic			2% CHRYSOTILE	98% NON FIBROUS MATERIAL
	Black, Bituminous				
<b>484611-055</b>	08/11/22	55	701 KT FL		
Layer 1:	Floor Tile			No Asbestos Detected	100% NON FIBROUS MATERIAL
	Yellow, Organically Bound				
Layer 2:	Mastics			2% CHRYSOTILE	98% NON FIBROUS MATERIAL
	Tan/Black, Soft/Bituminous				
<b>Unable to separate individual layers.</b>					
<b>484611-056</b>	08/11/22	56	706 BR FL		
Layer 1:	Floor Tile			No Asbestos Detected	100% NON FIBROUS MATERIAL
	Cream, Organically Bound				
Layer 2:	Mastic			No Asbestos Detected	100% NON FIBROUS MATERIAL
	Tan, Soft				
<b>484611-057</b>	08/11/22	57	706 KT Sink		
Layer 1:	Caulk			No Asbestos Detected	100% NON FIBROUS MATERIAL
	Gray, Soft				
<b>484611-058</b>	08/11/22	58	706 BA Sink

**Sample #54 cream 12x12 floor tiles & mastic**

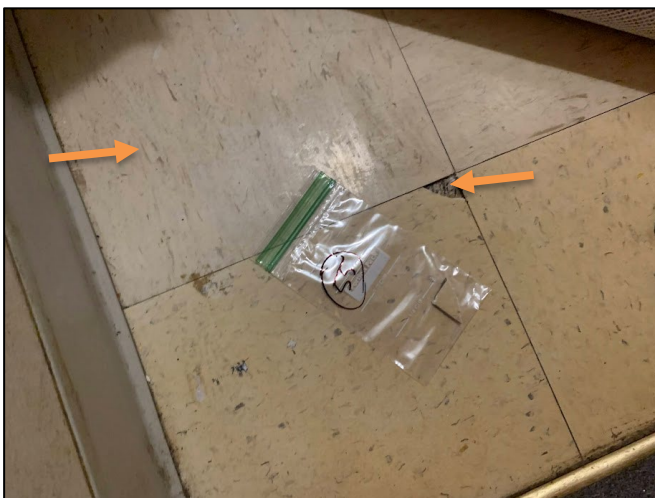
**Sample #55 black floor mastic & assumed 12x12 cream floor tiles**

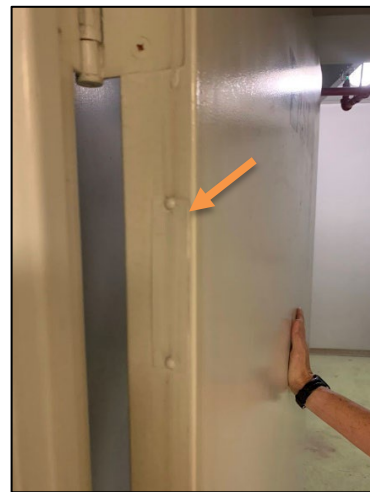
ASSUMED MATERIAL	ASSUMED ACBM LOCATION
Fire doors	All floors – stairwells at ends of halls
Elevator insulation/brake components	Elevator shaft at center of building
12x12 cream floor tiles & black mastic	Because it is impossible to test each floor tile, all 12x12 cream floor tiles throughout the building matching those testing positive, and all black floor mastic should be considered to be asbestos containing.

**Assumed – fire door at stairwells/end of each hall**

Based on conversations with the Client, it is understood that the subject building is going to be extensively remodeled. Please remember that all work involving ACM should always be conducted by properly trained and accredited workers utilizing the required containment, signage, and protective equipment.
