## ASBESTOS SCREENING REPORT

Rosedale Tower  
2314 W 39th Ave  
Kansas City, Kansas 66103

Hernly Environmental, Inc.  
Michelle Nelson & Katie Burnham  
AHERA Asbestos Inspector Cert. #  
7ACT031617IR-4047 & 7ACT031617IR-4048  
1100 Rhode Island Street  
Lawrence, Kansas 66044  
TEL: (785) 749-5806  
FAX: (785) 749-1515  
[www.hernly.com](http://www.hernly.com)  
HE Project No.: 170802-01MK

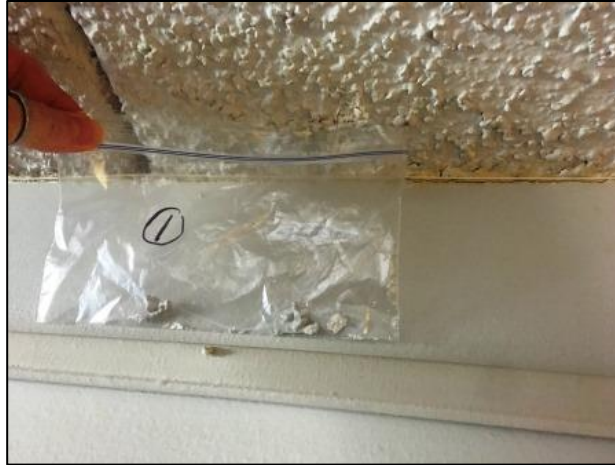
Sample #	Item Description	Location	*Approx. Amount
224723-01	Ceiling texture	Unit #1209	Throughout unit - 787sf
224723-03	Ceiling texture	Unit #1107	Throughout unit - 514sf
224723-07	Ceiling texture	Unit #903	Throughout unit - 514sf
224723-09	Ceiling texture	Unit #904	Throughout unit - 514sf
224723-11	Ceiling texture	Unit #804	Throughout unit - 514sf
224723-13	Ceiling texture	Unit #707	Throughout unit - 514sf
224723-17	Ceiling texture	Unit #505	Throughout unit - 514sf
224723-19	Ceiling texture	Unit #402	Throughout unit - 514sf
224723-21	Ceiling texture	Unit #307	Throughout unit - 514sf
224724-3	Ceiling texture	Unit #1104	Throughout unit - 514sf
224724-5	Ceiling texture	Unit #1103	Throughout unit - 514sf
224724-7	Ceiling texture	Unit #1101	Throughout unit - 514sf
224724-9	Ceiling texture	Unit #905	Throughout unit - 514sf
224724-11	Ceiling texture	Unit #807	Throughout unit - 514sf
224724-13	Ceiling texture	Unit #704	Throughout unit - 514sf

Sample #	Item Description	Location	*Approx. Amount
224273-01	Ceiling Texture	Unit #1209	Throughout unit - 787sf
224273-02	Joint Compound	Unit #1209	Throughout unit at drywall seams, nail holes, and patches
224273-03	Ceiling Texture	Unit #1107	Throughout unit - 514sf
224273-04	Joint Compound	Unit #1107	Throughout unit at drywall seams, nail holes, and patches
224273-06	Joint Compound	Unit #1104	Throughout unit at drywall seams, nail holes, and patches
224273-07	Ceiling Texture	Unit #903	Throughout unit - 514sf
224273-08	Joint Compound	Unit #903	Throughout unit at drywall seams, nail holes, and patches
224273-09	Ceiling Texture	Unit #904	Throughout unit - 514sf
224273-10	Joint Compound	Unit #904	Throughout unit at drywall seams, nail holes, and patches
224273-11	Ceiling Texture	Unit #804	Throughout unit - 514sf
224273-12	Joint Compound	Unit #804	Throughout unit at drywall seams, nail holes, and patches

Typical asbestos containing ceiling texture

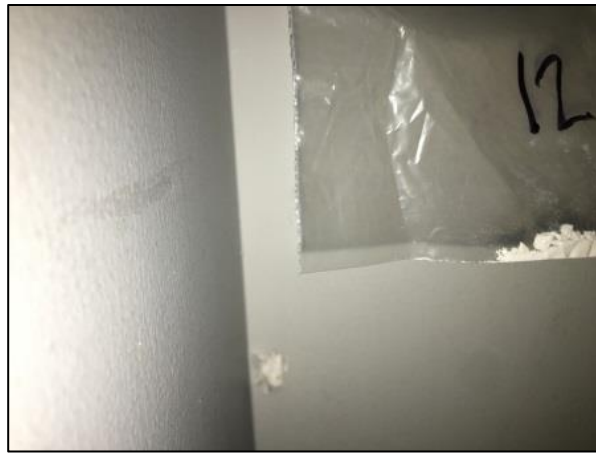
Typical asbestos containing joint compound

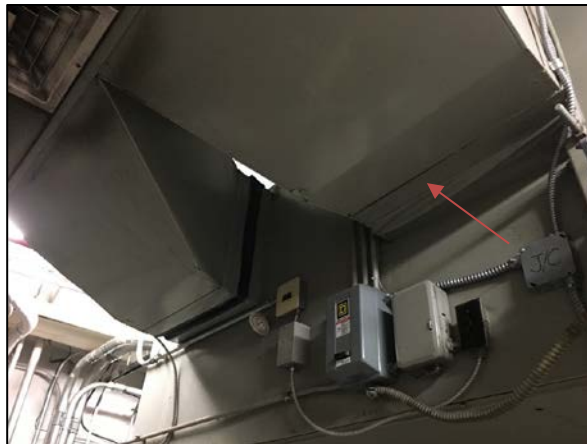
ASSUMED MATERIAL	ASSUMED ACBM LOCATION
Ceiling texture	All untested textured ceilings throughout building
Joint compound	All untested areas throughout building (**per OSHA standards)
Vibration dampener fabric	Air handler -Mechanical Room

Vibration dampening fabric in mechanical room

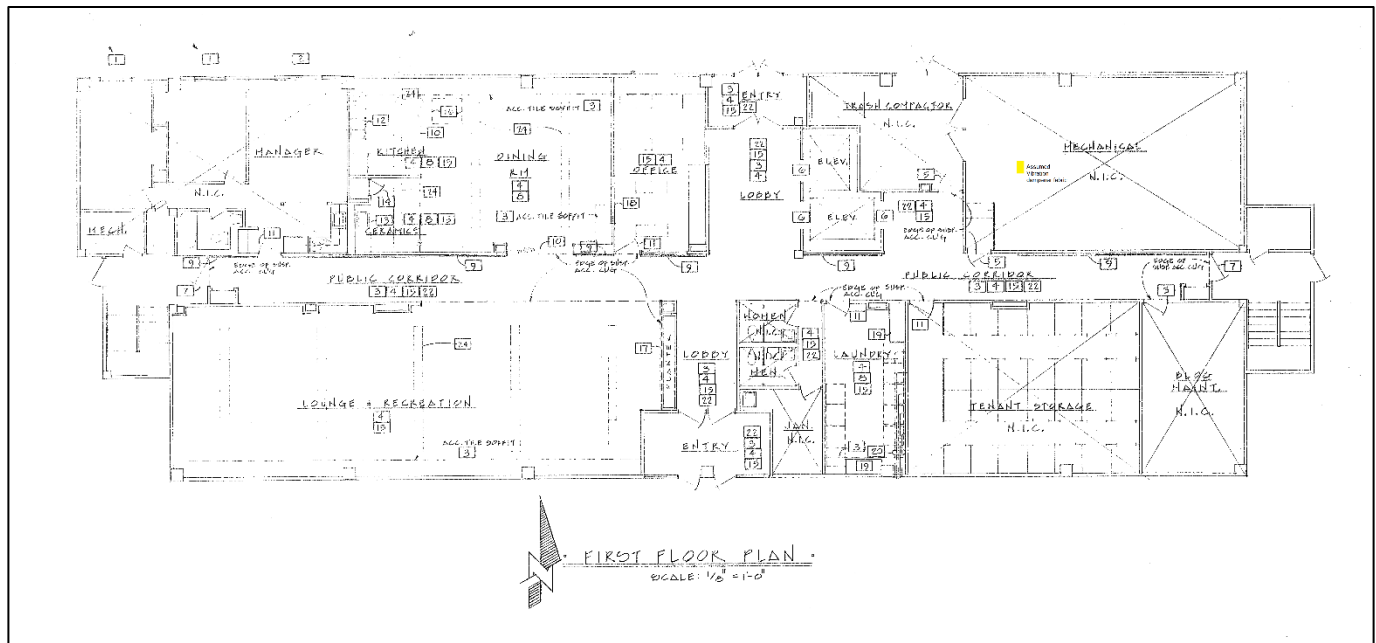
**ASBESTOS CONTAINING CEILING TEXTURE & JOINT COMPOUND (PER OSHA STANDARDS) IDENTIFIED OR ASSUMED THROUGHOUT BUILDING, ASSUMED VIBRATION DAMPENING FABRIC IN MECHANICAL ROOM**
