# Site Observation Report

## Kansas City Kansas Housing Authority - Plaza Tower Interior Modernization – Phase 3

March 25, 2024

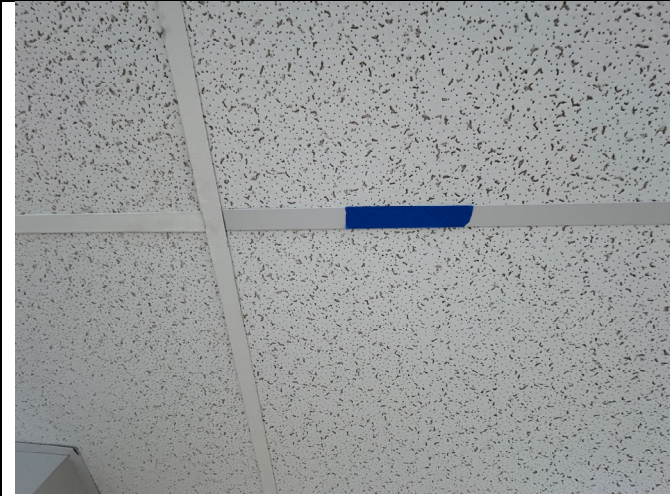
1. Gypsum board finish and paint deficiencies were marked with blue tape.
2. Replaced T-grid and wall angle ceiling grid has not been painted to match existing ceiling grid.
3. Some areas require a bead of caulk and some paint where wall board meets ceiling grid wall angle. These areas have been identified with blue tape.
4. Clean paint from solid surface window sill just south of column bump-out at exterior wall.
5. Non-matching floor tiles were used adjacent to Door A-209.

Infill T-grid not the same color as painted grid in Common Space 208.

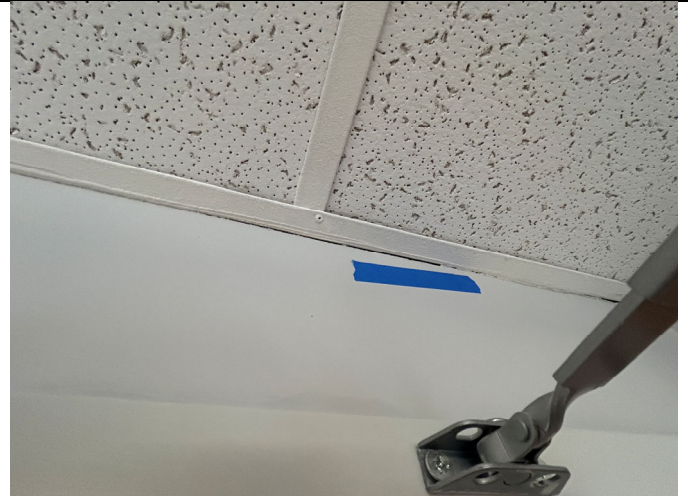
Gap at existing ceiling wall angle requiring caulking & paint in Common Space 208.

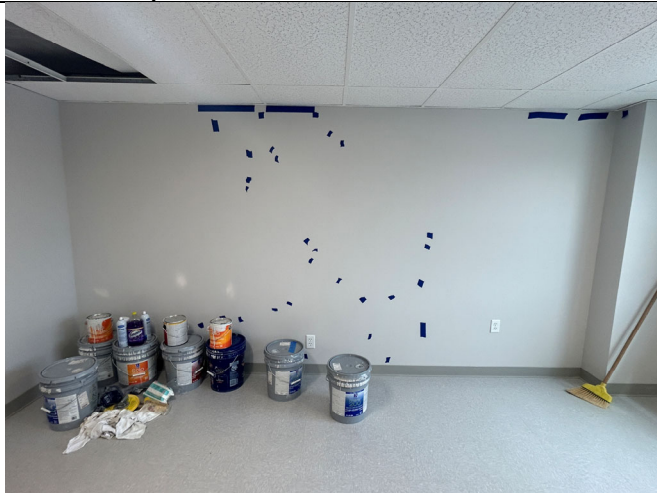
North wall of Common Space 208 with gypsum board finish deficiencies identified w/ blue tape.

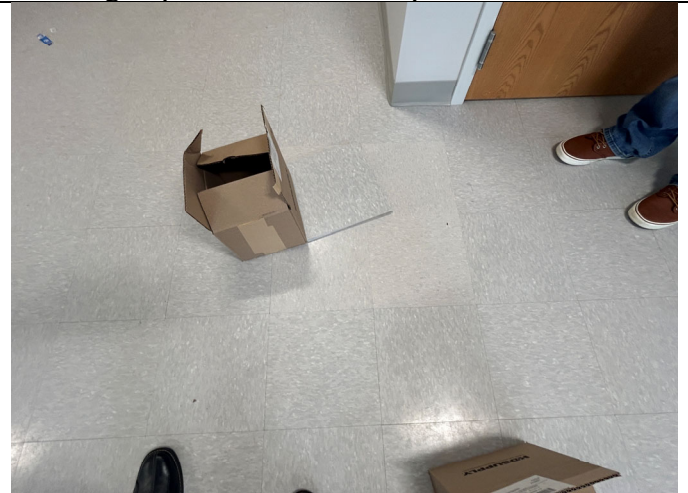
Vinyl floor tiles in Common Space 208 to be replaced with matching tiles.

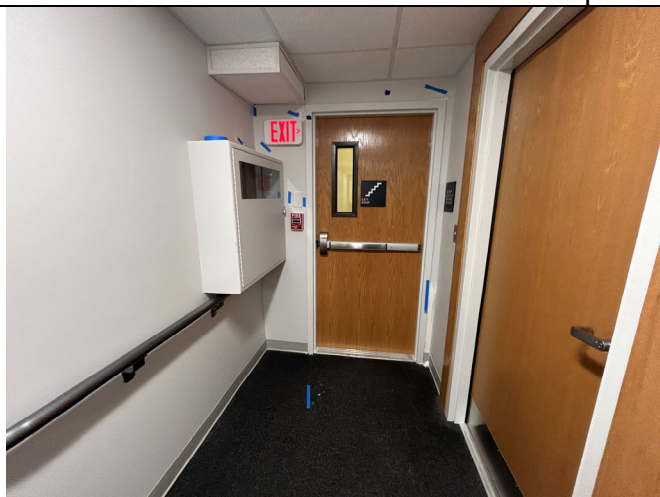
South stairwell door with gypsum board finish deficiencies identified w/ blue tape.

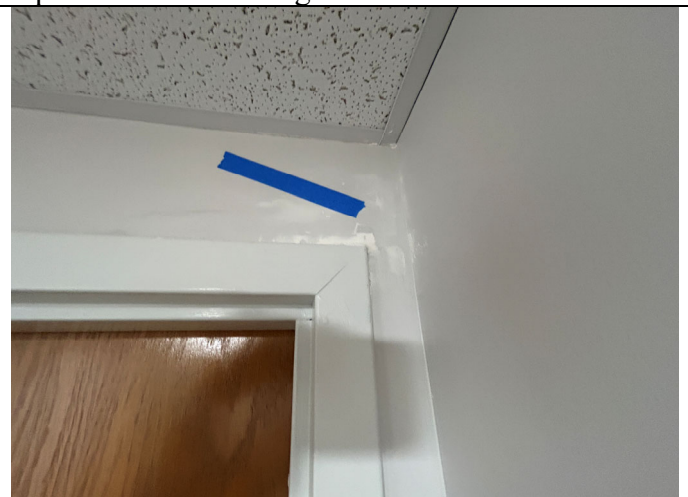
Gypsum board finish touch-up and paint required in south corridor above stairwell door.

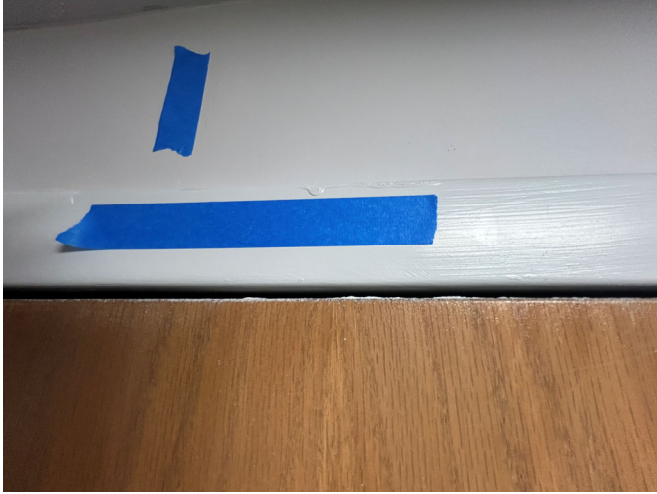
Paint drip & heavy brush strokes visible above jan closet door in corridor.

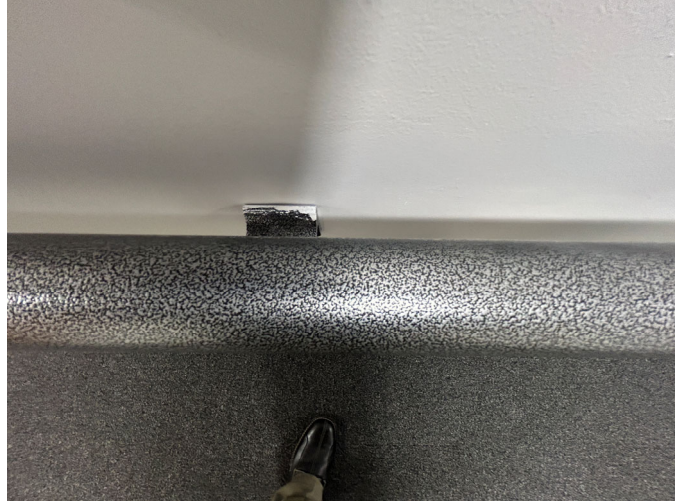
5. Some paint (likely from paint touch-up) is visible on the handrail brackets throughout the corridors. The paint should be removed from these brackets.

Wall paint visible on handrail brackets in corridor.

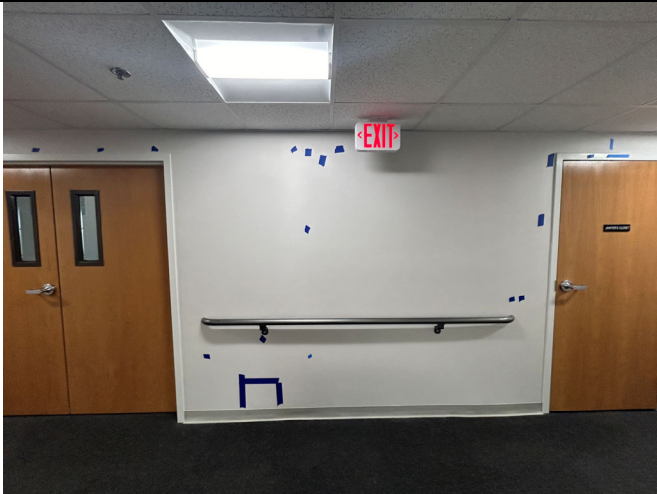
Gypsum board finish deficiencies identified w/ blue tape in corridor between Doors A-207 & A-208.

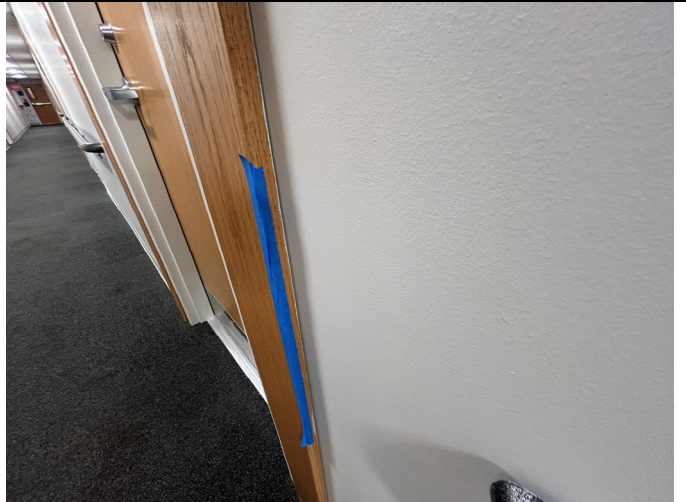
2. Some paint (likely from paint touch-up) is visible on the wood trim next to various unity entry doors. These areas were identified with blue tape. There is also a visual record in the pictures.

Paint to be removed from wood trim at a typical unit entry door in corridor.

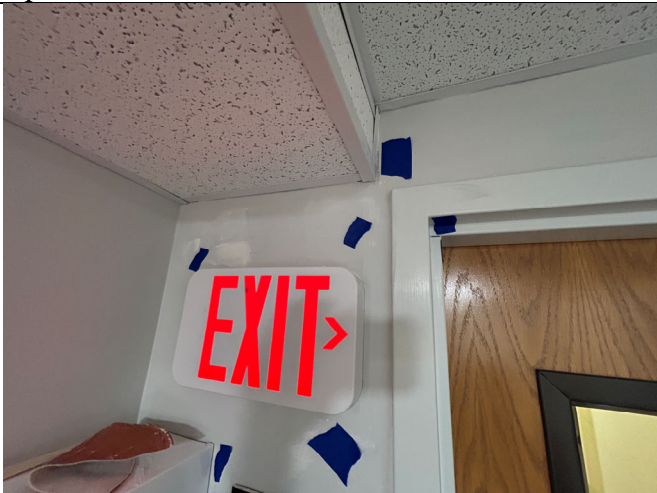
Gypsum board finish touch-up and paint required in north corridor above stairwell door.

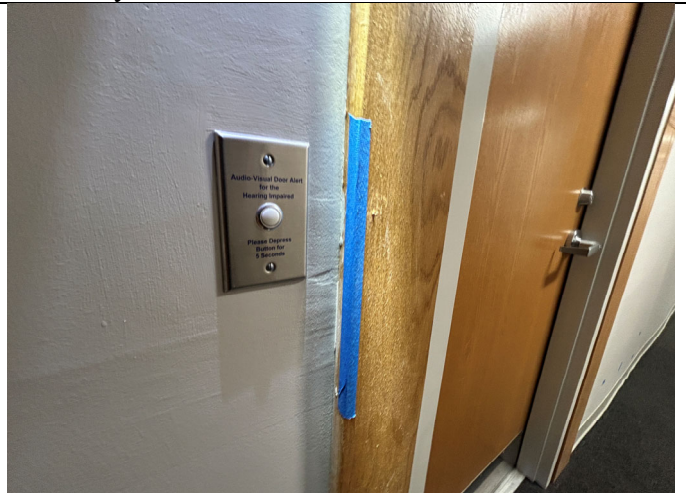
Gypsum board finish touch-up and paint required adjacent to unity entry door at Unit 201.

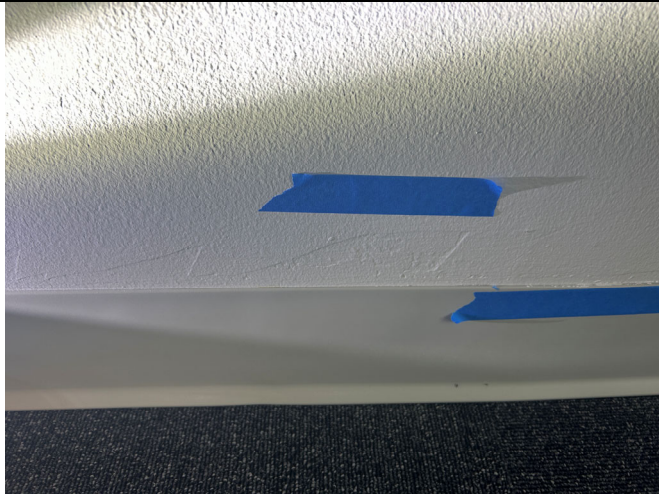
1. Gypsum board finish and paint deficiencies were marked with blue tape.
2. Gypsum board compound is built-up just above vinyl base on the wing wall separating the entry door from the kitchen.

Deficient gypsum board finish above base in Unit 214.

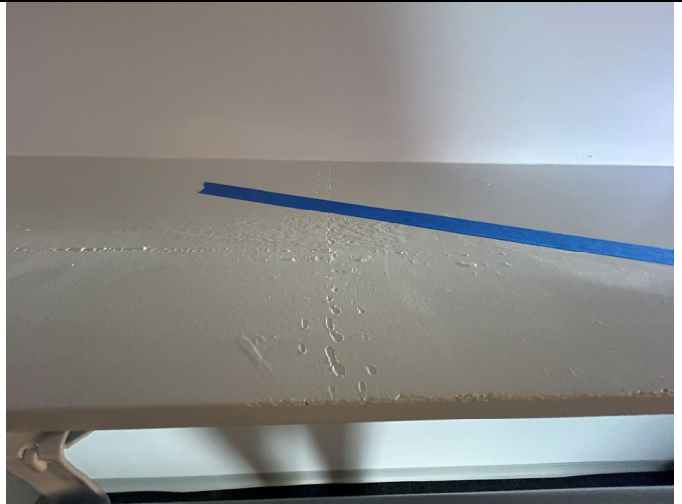
3. Some sanding & repainting is required where the wall meets the ceiling above the closet opening in the bedroom.
4. The wood shelf in the bedroom closet is installed upside down.

Visible side of wood shelf in bedroom closet at Unit 214.

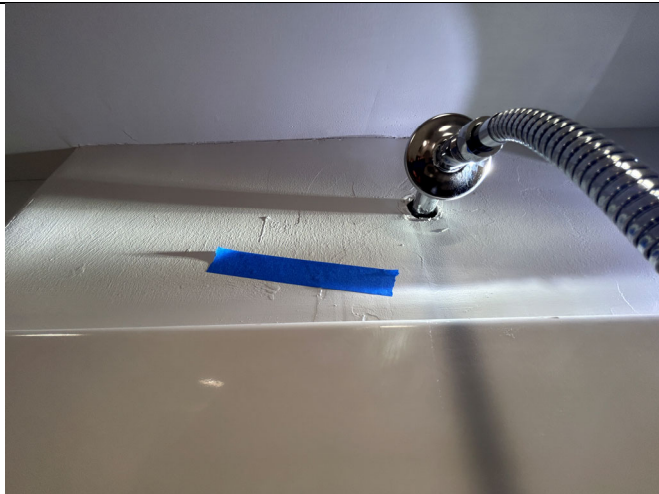
Deficient gypsum board finish at shower head in Unit 214.

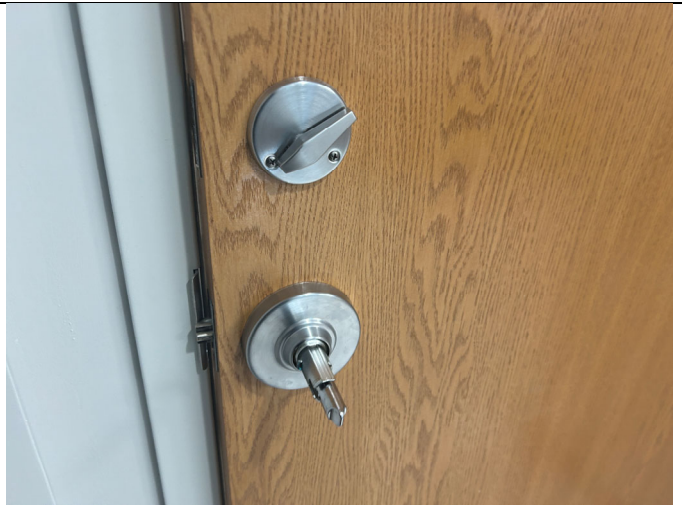
7. Left and right-hand sides of the wood frame at the bathroom door (bathroom side) require caulking & repainting for a proper finish.
8. Lockset handle is not secured at unit entry door (unit side).

Lockset door handle in Unit 214 to be secured.

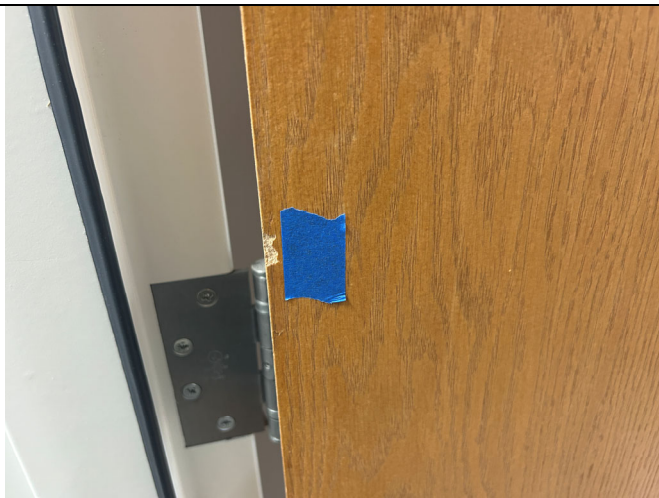
9. There are signs of delamination of the wood veneer at the unity entry door.
10. The wood veneer has been damage on the hinge side (exposed to corridor).

Damaged wood veneer to unit entry door at Unit 214.

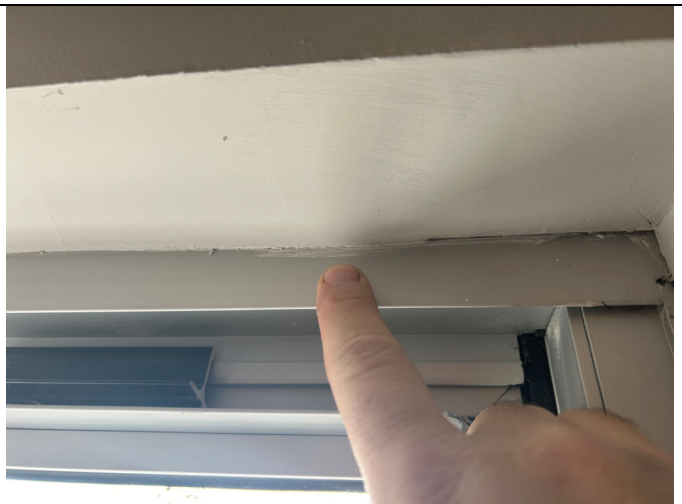
Paint on window frame in Unit 212. This is a typical condition.

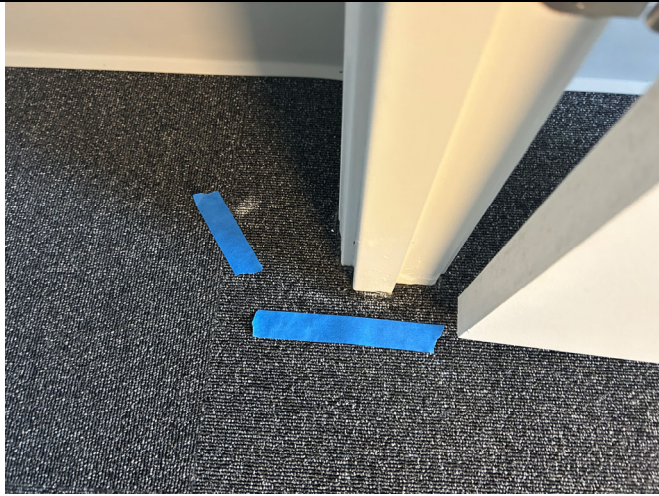
5. The upper left-hand side of the door frame for the closet in Bedroom 1 requires sanding and repainting for a proper finish.
6. The wood shelf in the closet of Bedroom 2 has been installed upside down.
7. Paint was observed on the carpet in the closet of Bedroom 2.

Paint on carpet in Bedroom 2 closet in Unit 211.

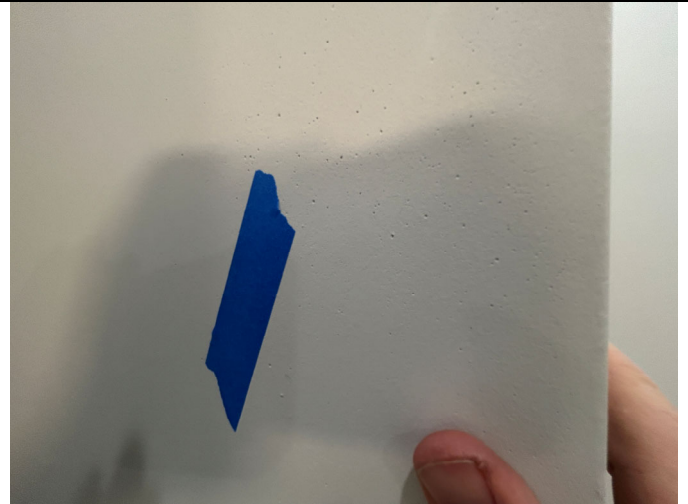
Multiple pock marks in drywall finish in Unit 210. This has occurred in multiple units and locations.

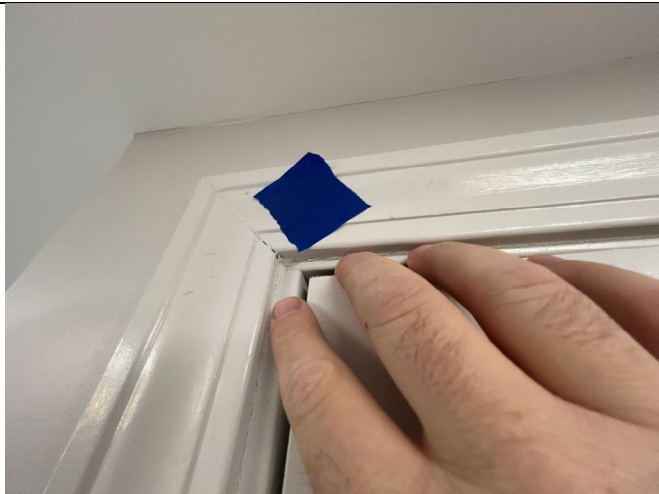
Wood door frame requiring additional wood filler, sanding, and repainting. Typical in various units.

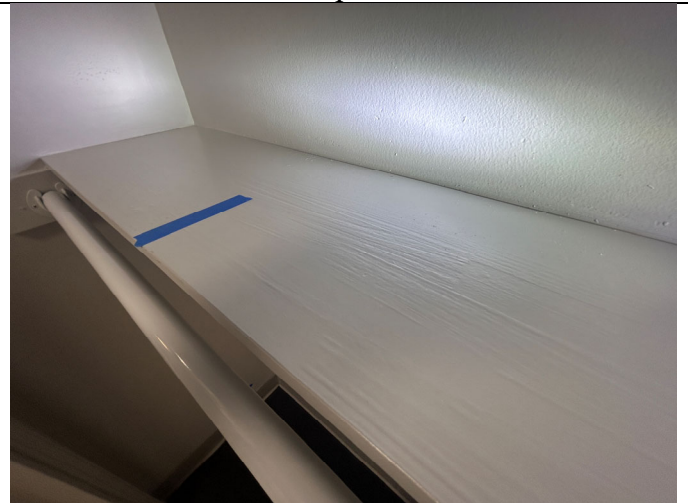
Wood shelf installed upside down in closet of Unit 209. Typical in multiple units.

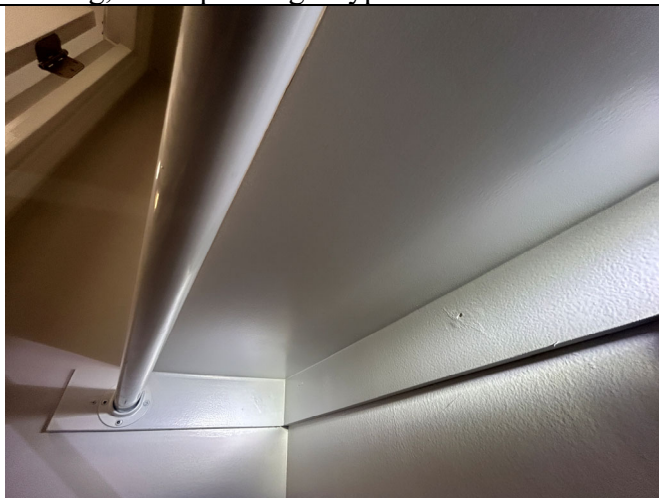
Finish side of bedroom closet in Unit 209 noted above as viewed from the underside.

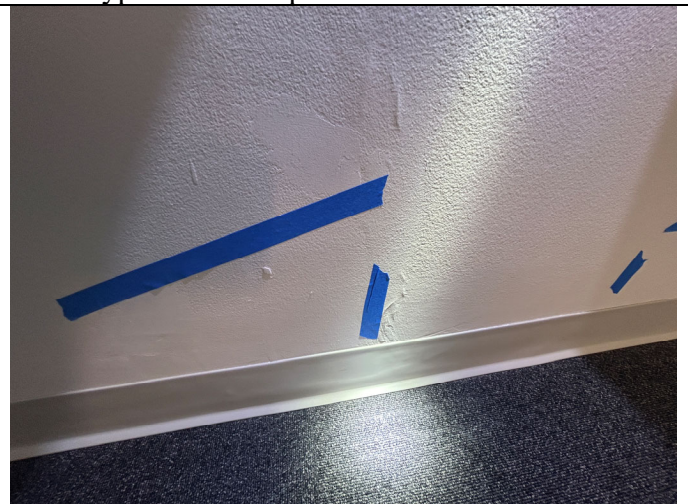
Condition at existing wall in Unit 207 that has not been finished to "like new" condition.
