## ASBESTOS SCREENING REPORT

Rosedale Tower  
2314 W 39th Ave  
Kansas City, Kansas 66103

Hernly Environmental, Inc.  
Michelle Nelson & Katie Burnham  
AHERA Asbestos Inspector Cert. #  
7ACT031617IR-4047 & 7ACT031617IR-4048  
1100 Rhode Island Street  
Lawrence, Kansas 66044  
TEL: (785) 749-5806  
FAX: (785) 749-1515  
[www.hernly.com](http://www.hernly.com)  
HE Project No.: 170802-01MK

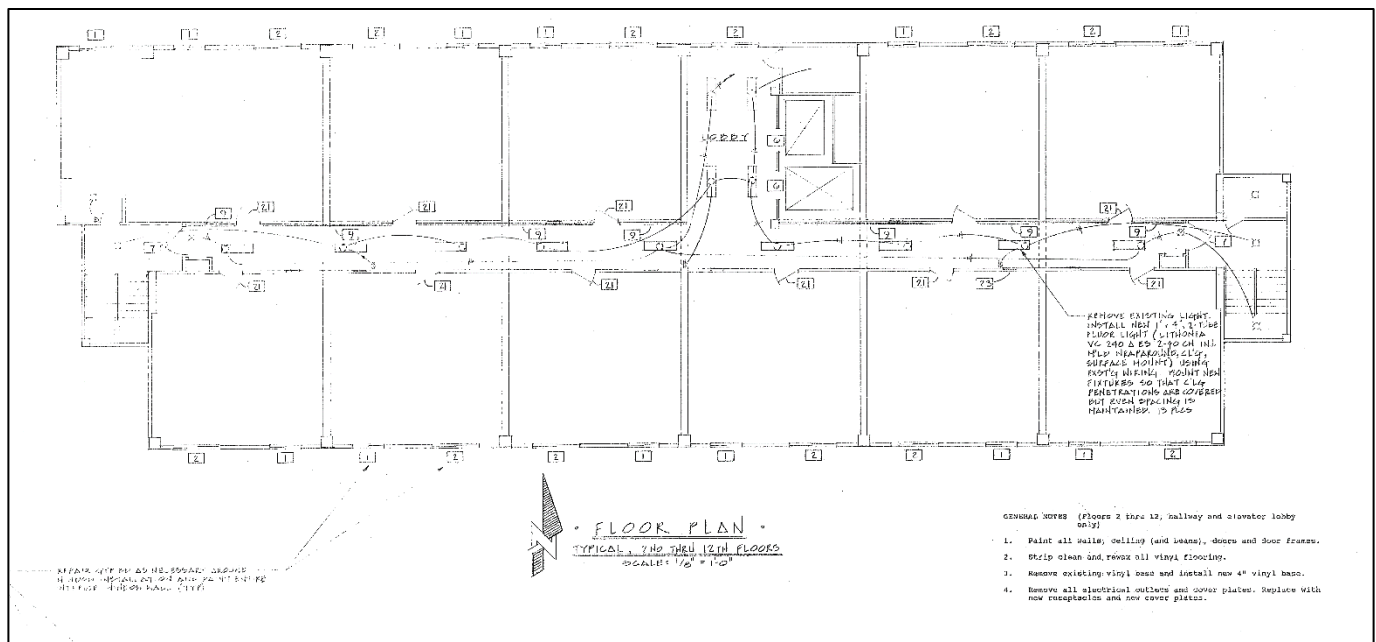
**ASBESTOS CONTAINING CEILING TEXTURE & JOINT COMPOUND (PER OSHA STANDARDS) IDENTIFIED OR ASSUMED THROUGHOUT BUILDING, ASSUMED VIBRATION DAMPENING FABRIC IN MECHANICAL ROOM**
